Evaluation of Nondestructive Methods for Determining Pavement Thickness

Lulu Edwards and Quint Mason

September 2011

Final report

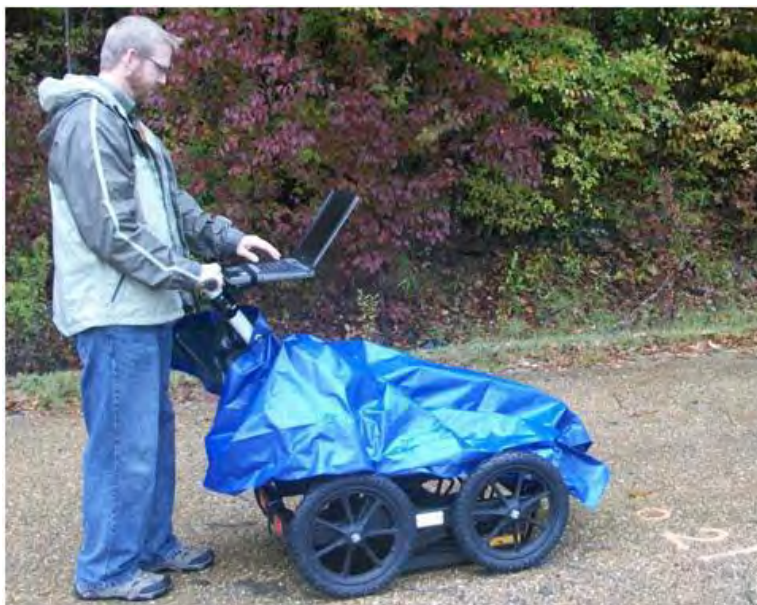
Figure 34. Testing during intermittent rain.

There was significant rain during the day of testing. Only light rain occurred during the actual data acquisition period. A tarp, as seen in Figure 34, was used to protect the equipment.

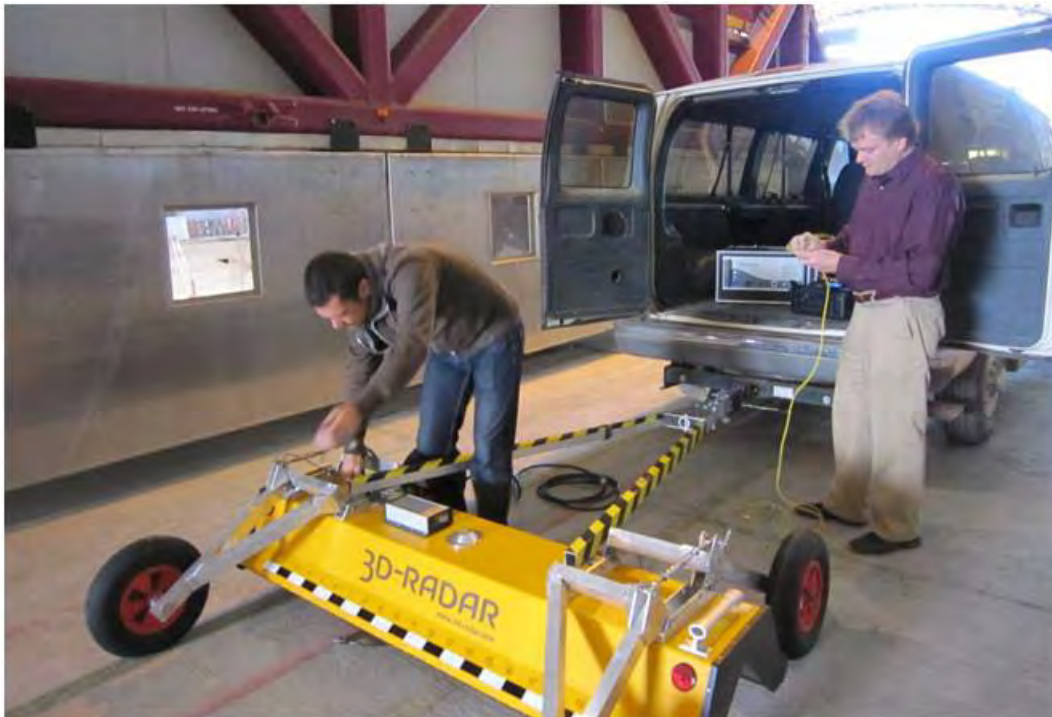
Figure 35. Setup of the 3D-Radar system.

Setup of the equipment, shown in Figure 35, required approximately 1 hr. Data were collected as the antenna traveled over the test location (Figure 36). High resolution data were collected during testing, and thus the vehicle had to travel at a slow speed averaging 2 mph. Because there are multiple channels, it was easier to align the antenna to the test location. One person walked behind the antenna and would notify the operator when the antenna reached the test location. The horizontal position of the test location was noted by the channel number labeled on the antenna. This ensured that the exact test location was measured.

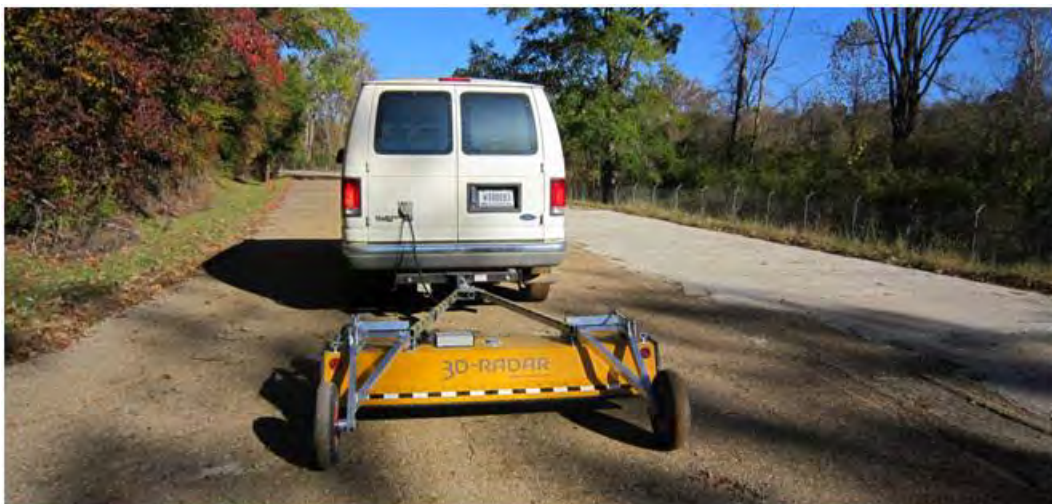
Figure 36. Testing with the 3D-Radar system.

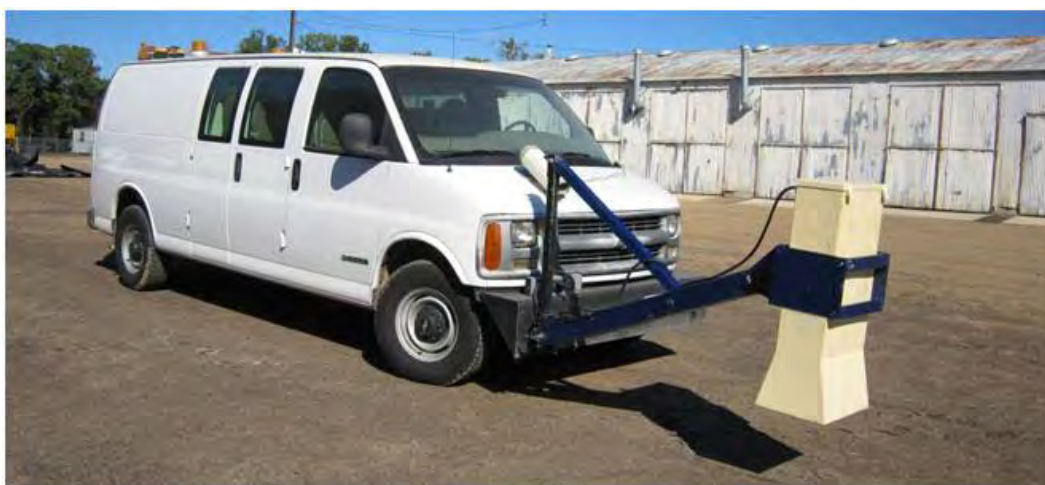
Figure 37. ERDC 1-GHz horn antenna.

The GPR system discussed in this report (Figure 37) was developed by Pulse Radar, Inc., under a Small Business Innovative Research (SBIR) project with the ERDC. This system consists of three air-coupled antennas: a 1-GHz antenna that penetrates up to 1 m (3.3 ft), a 500-MHz antenna that penetrates up to 2 m (6.6 ft), and a 250-MHz antenna that penetrates up to 3 m (9.8 ft). There is one ground-coupled antenna of 100 MHz that can penetrate from 5 to 10 m (16.4 to 32.8 ft). The system is designed to be rugged, can collect data in the temperature range of -10 to 50 °C (14 to 122 °F), and can tolerate relatively high humidity, rain, dust, shock, and vibrations that are frequently encountered during field testing (Pulse Radar 1995). Only the 1-GHz antenna was used for this study. The original software was replaced in 2007 with ColorMap, Version 2.1, which was developed by the Texas Transportation Institute of Texas A&M University. This software improved the pavement thickness determination, was more user-friendly, and could operate in the Windows XP operating system.

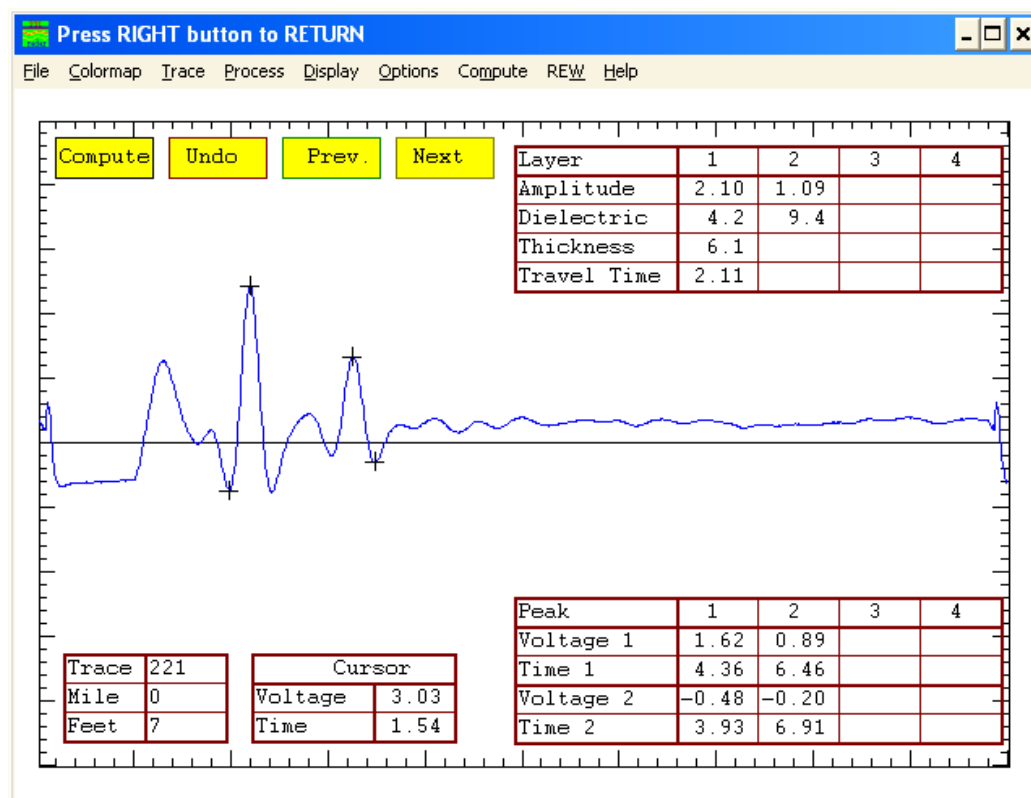
Figure 38. Data processing with the 1-GHz Pulse Radar horn antenna (ERDC) system.

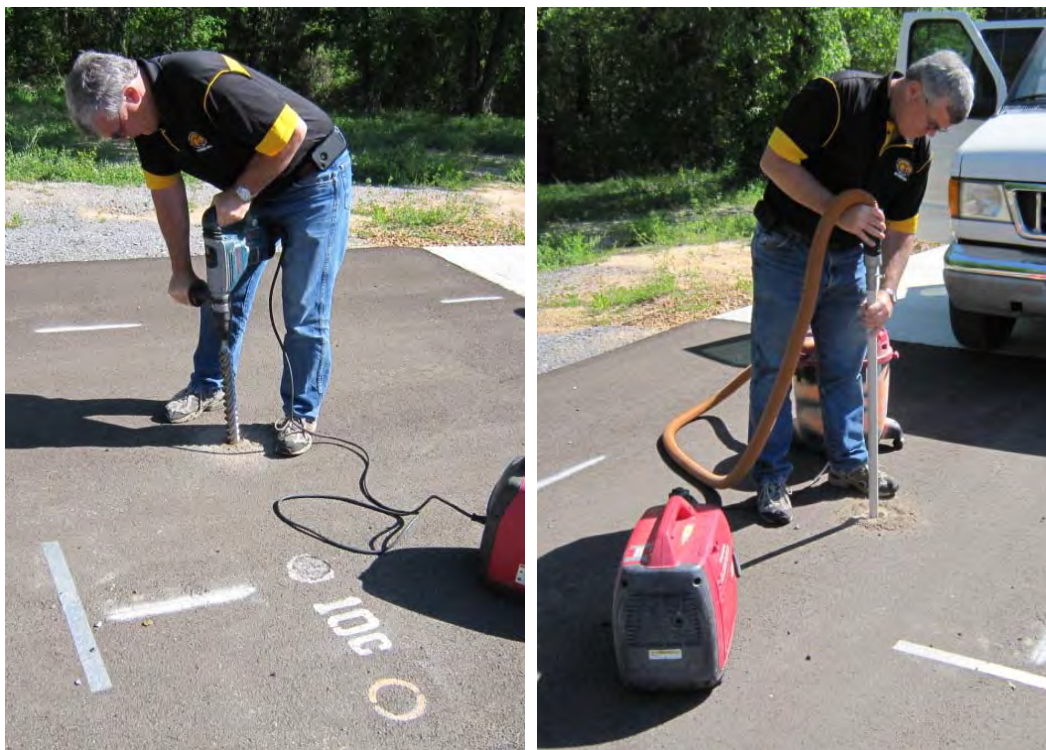
Figure 39. Drilling a 2-in. hole and vacuuming the fines out of the hole.

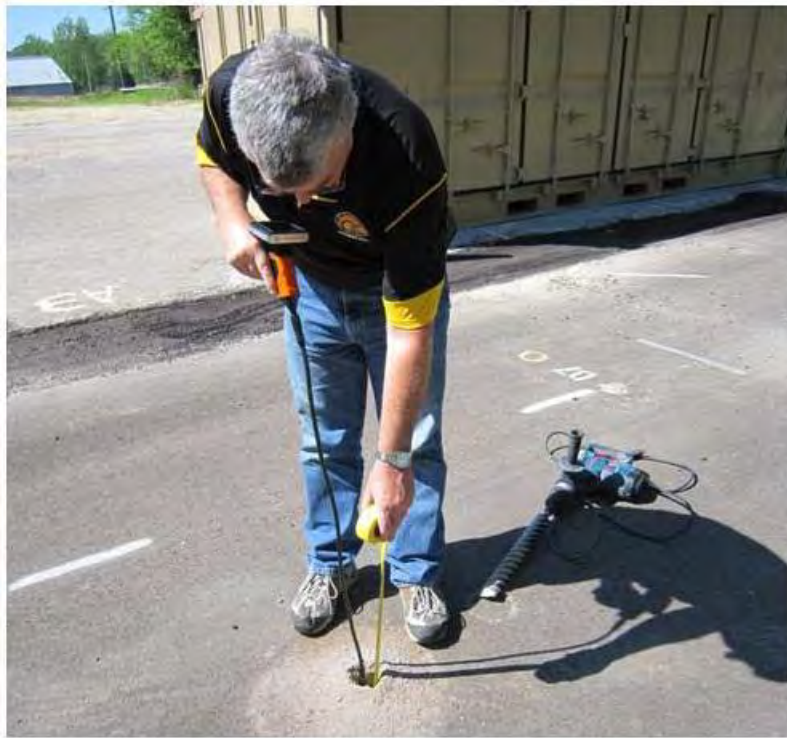
Figure 40. Using the borescope and measuring tape inside the drilled hole.

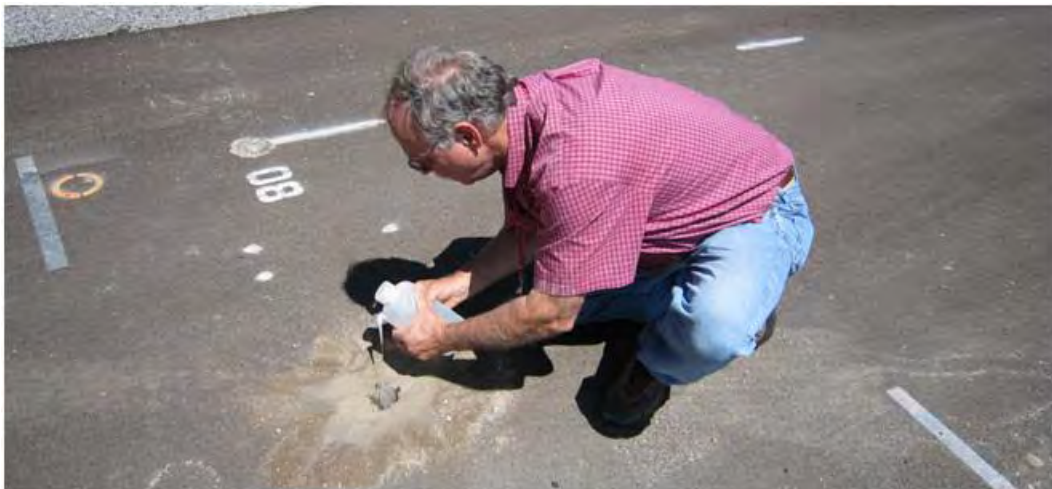
Figure 41. Washing the drilled hole.

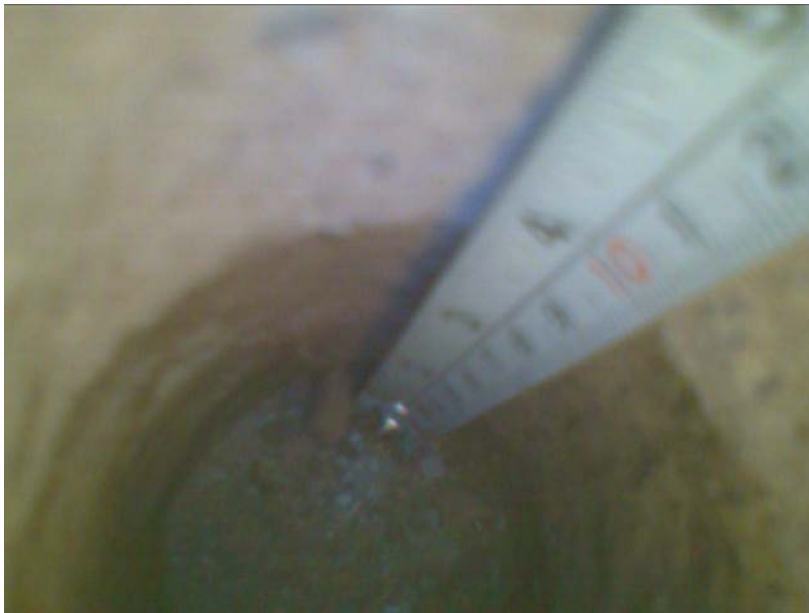
Figure 42. Snapshot from borescope camera.

8. Borescopes were not found to be effective at measuring pavement thickness in this evaluation. Use of the borescope is not nondestructive, but it was evaluated as a potential minimally destructive method. However, it is too difficult to create a clean inspection hole to view layer interfaces, and it is difficult to obtain a clear picture with the borescope camera.

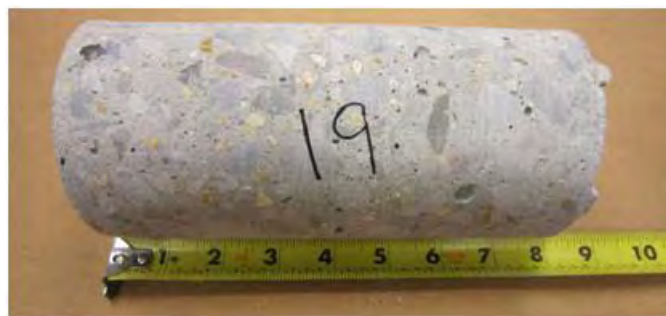
Figure 43. Measurement of PCC pavement layer for test location 19.

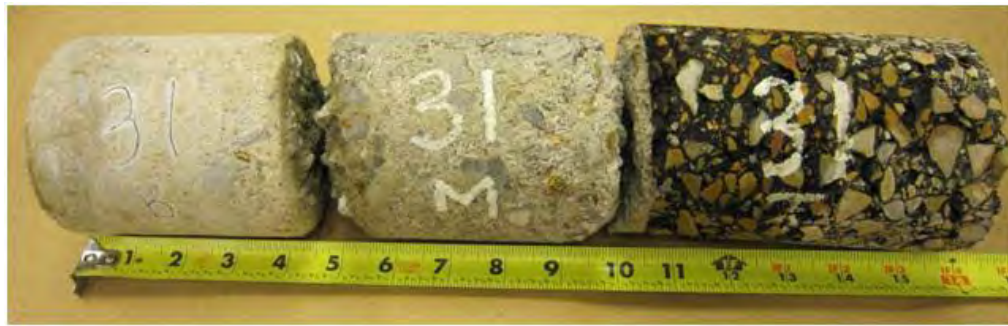
Figure 44. Measurement of pavement layers for test location 31.

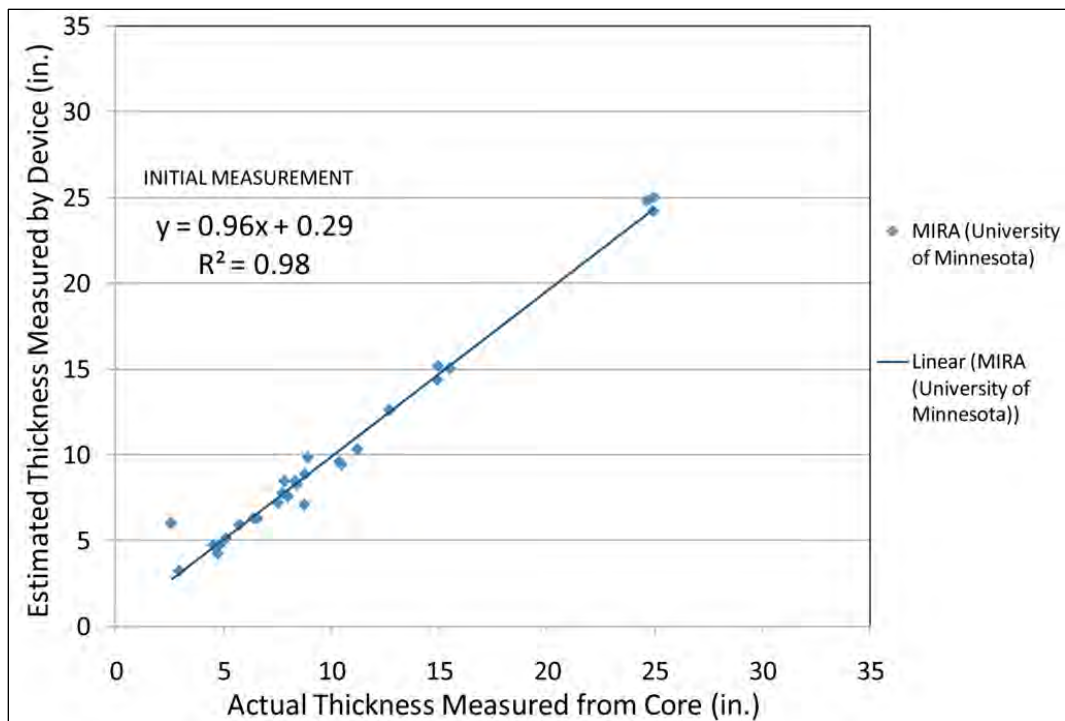
Figure 45. Correlation of actual core thickness and estimated thickness from the MIRA (University of Minnesota).

The devices were first evaluated on their performance for both AC and PCC sections. In Table 12, the R^2 , average error, and percentage of the test locations actually measured are reported. Graphs of the actual core measurements plotted against the device-measured thicknesses are shown in Figure 45 through Figure 55. The error for each test location for all devices can be found in the graphs in Appendix A, and the actual measurements can be found in the tables in Appendix A. The errors for the initial estimates, as well as after calibration, are plotted for comparison. The errors on the graph are limited to 5 in. to allow for better comparison among the devices.

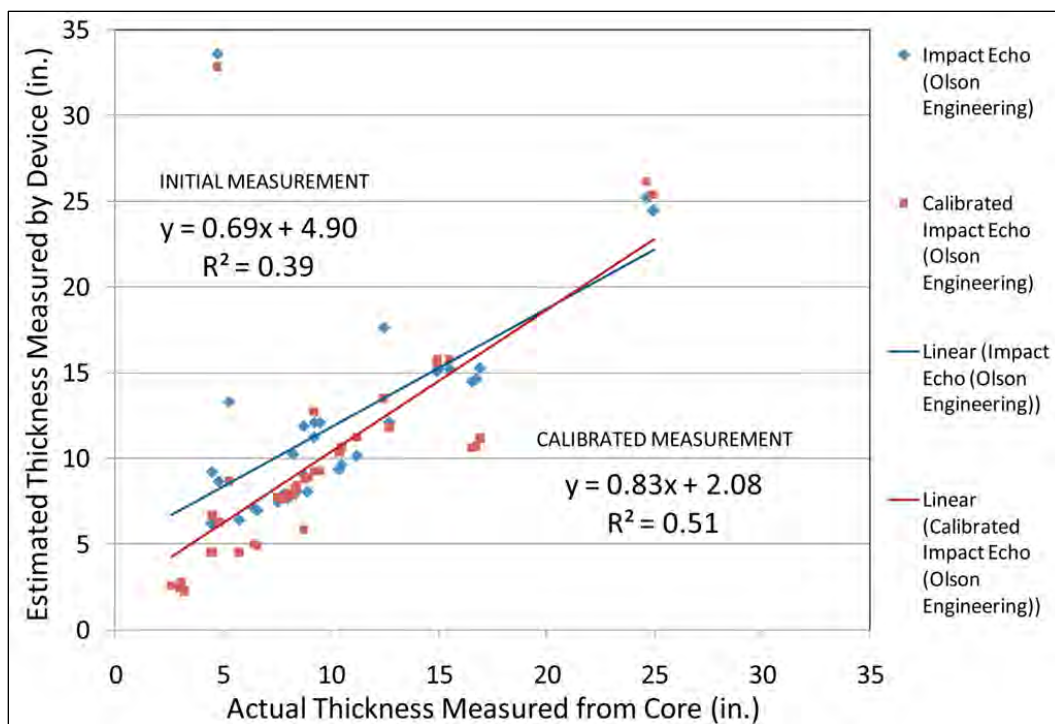
Figure 46. Correlation of actual core thickness and estimated thickness from impact echo (Olson Engineering).

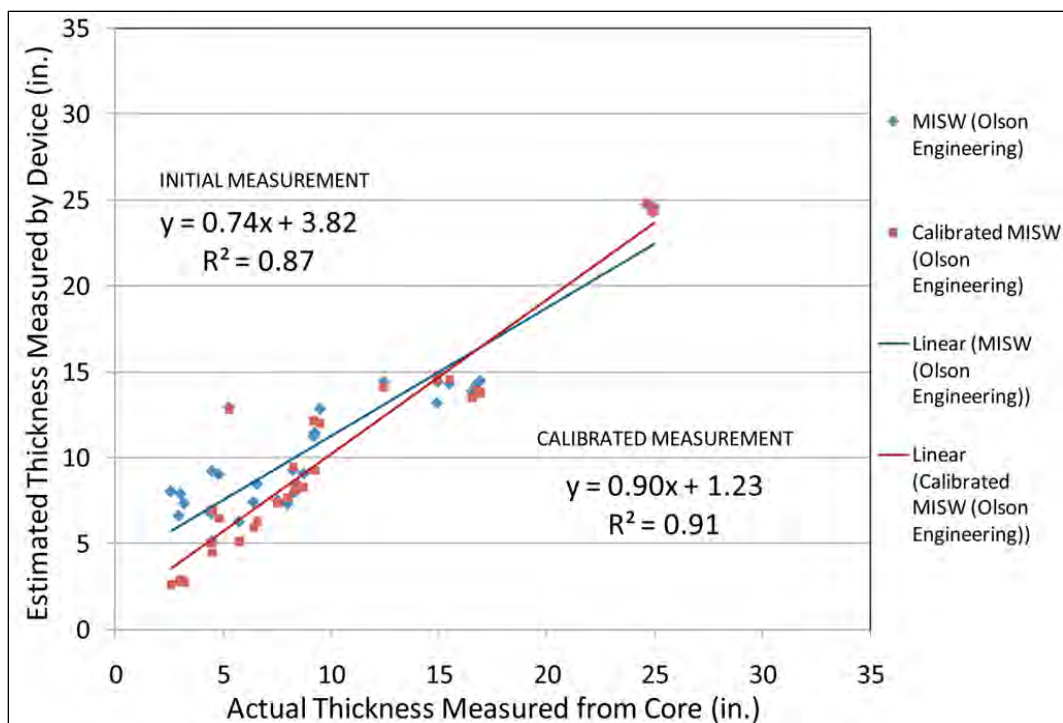
Figure 47. Correlation of actual core thickness and estimated thickness from the MISW (Olson Engineering).

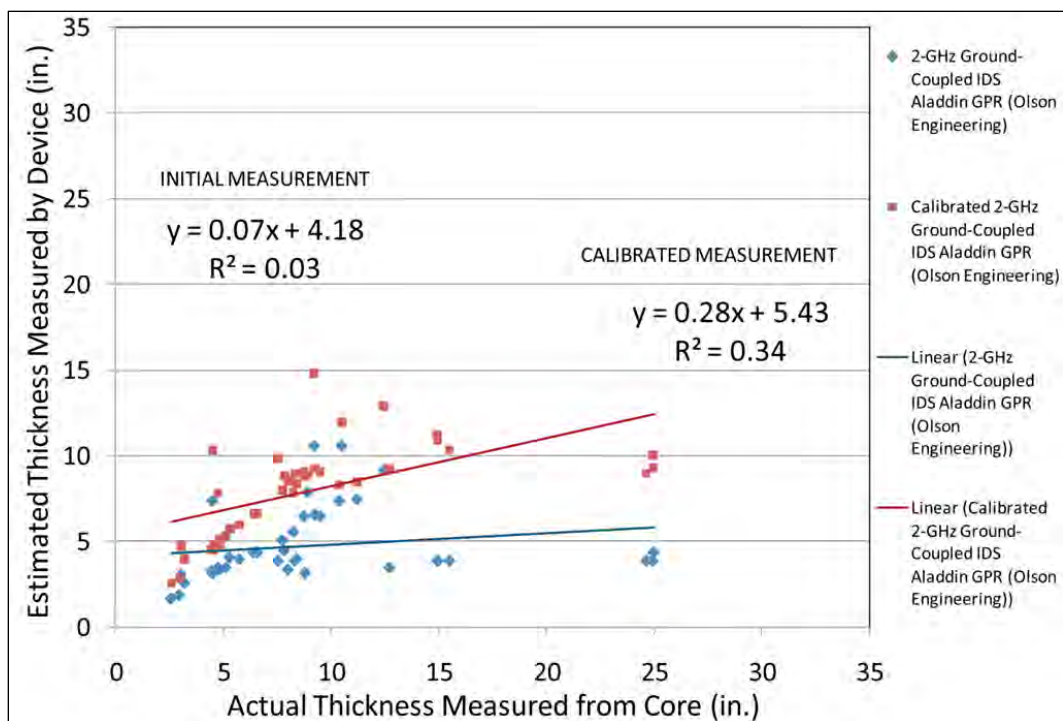
Figure 48. Correlation of actual core thickness and estimated thickness from the 2-GHz ground-coupled IDS Aladdin GPR (Olson Engineering).

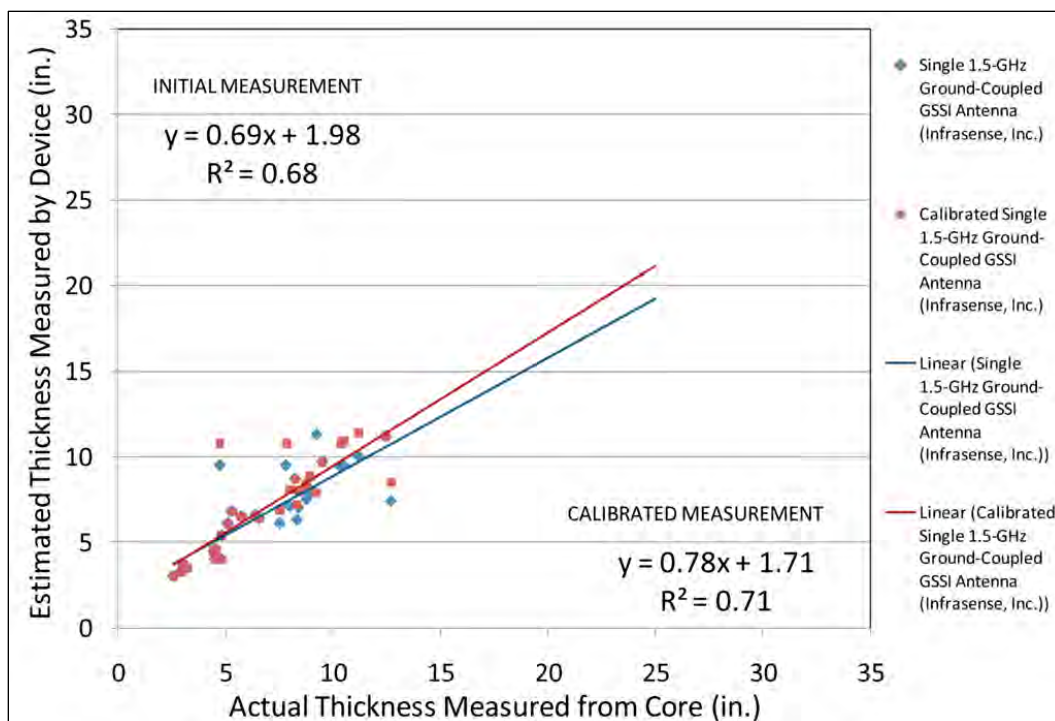
Figure 49. Correlation of actual core thickness and estimated thickness from the single 1.5-GHz ground-coupled GSSI antenna (Infrasense, Inc.).

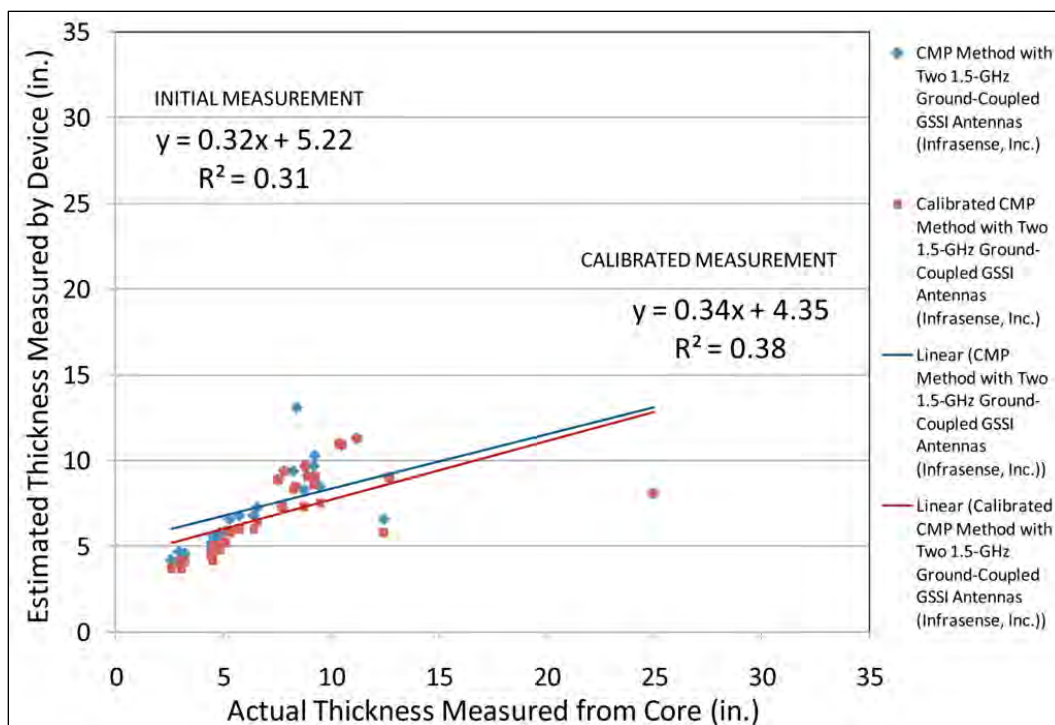
Figure 50. Correlation of actual core thickness and estimated thickness from the CMP method with two 1.5-GHz ground-coupled GSSI antennas (Infrasense, Inc.).

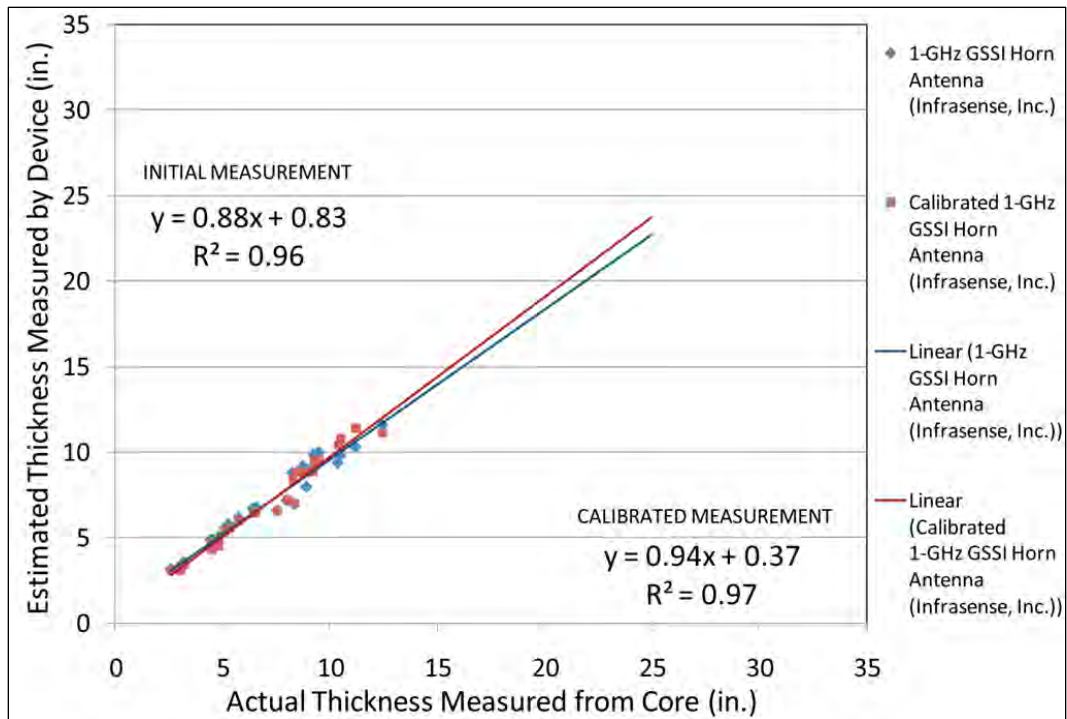
Figure 51. Correlation of actual core thickness and estimated thickness from the 1-GHz GSSI horn antenna (Infrasense, Inc.).

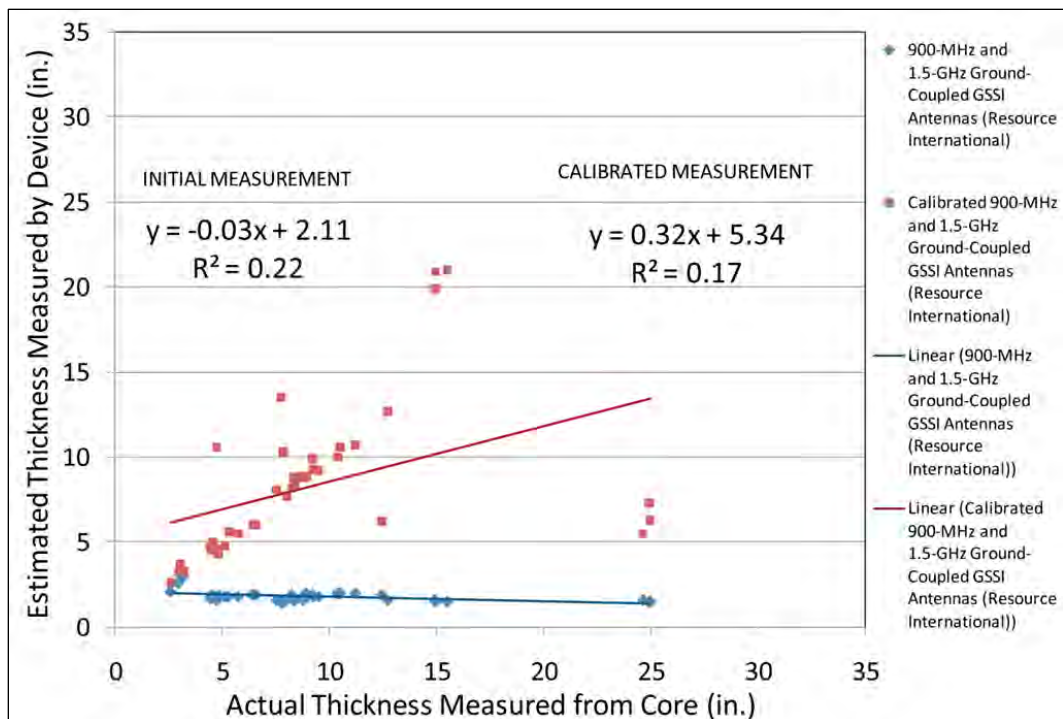
Figure 52. Correlation of actual core thickness and estimated thickness from the 900-MHz and 1.5-GHz ground-coupled GSSI antennas (Resource International).

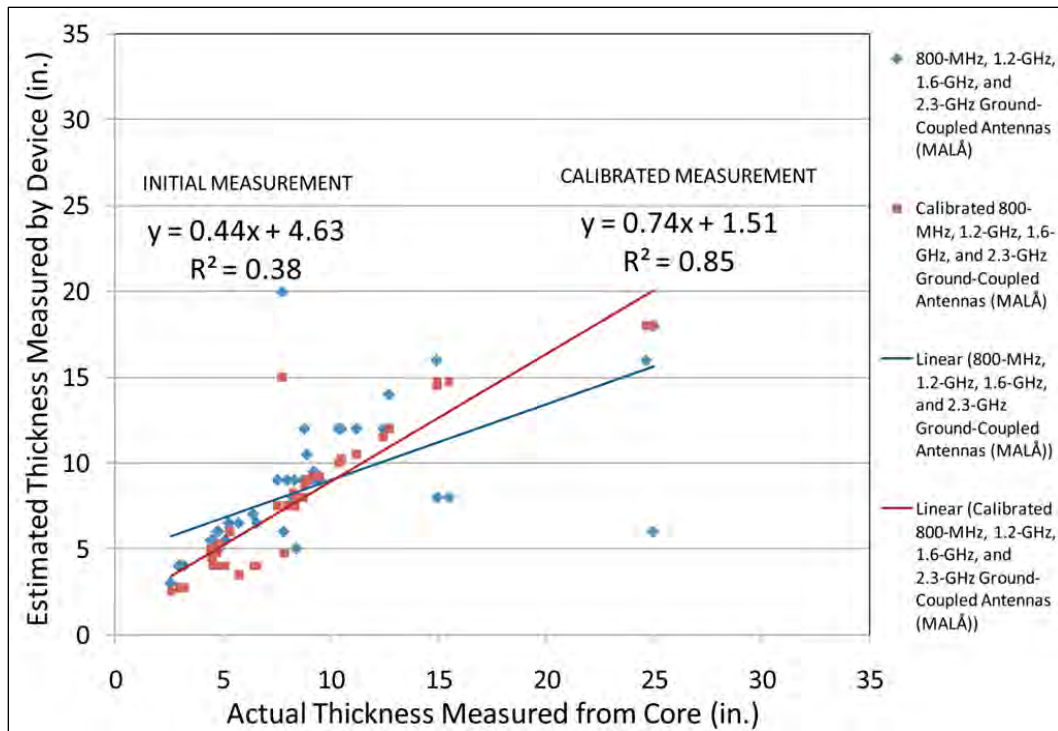
Figure 53. Correlation of actual core thickness and estimated thickness from the 800-MHz, 1.2-GHz, 1.6-GHz, and 2.3-GHz ground-coupled antennas (MALA).

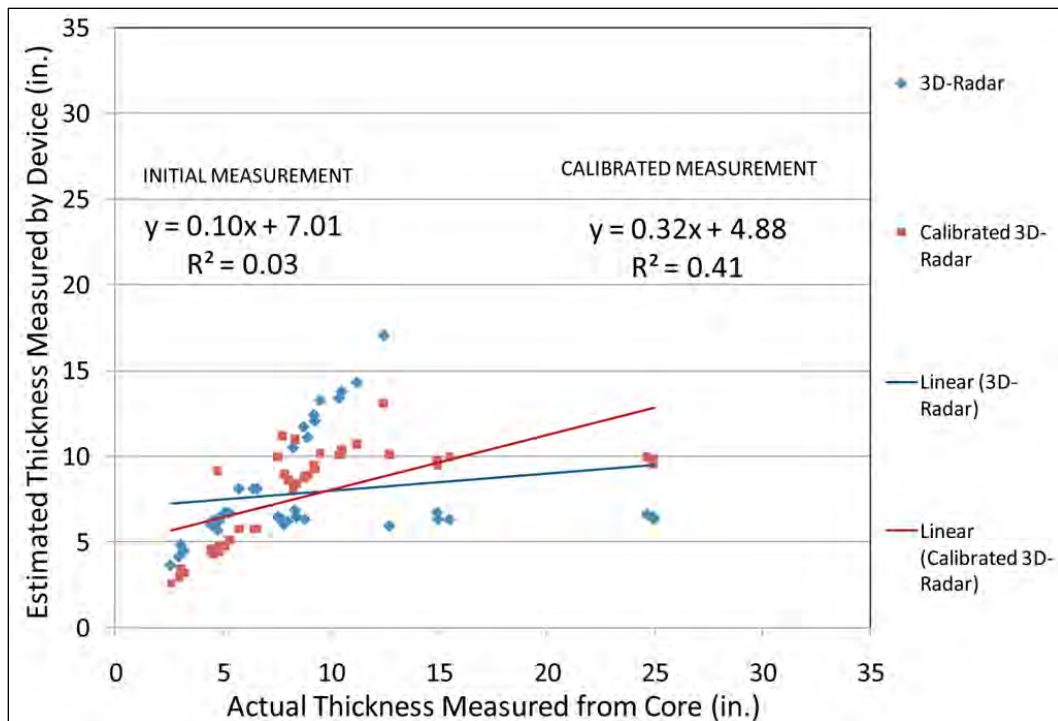
Figure 54. Correlation of actual core thickness and estimated thickness from 3D-Radar's GPR system.

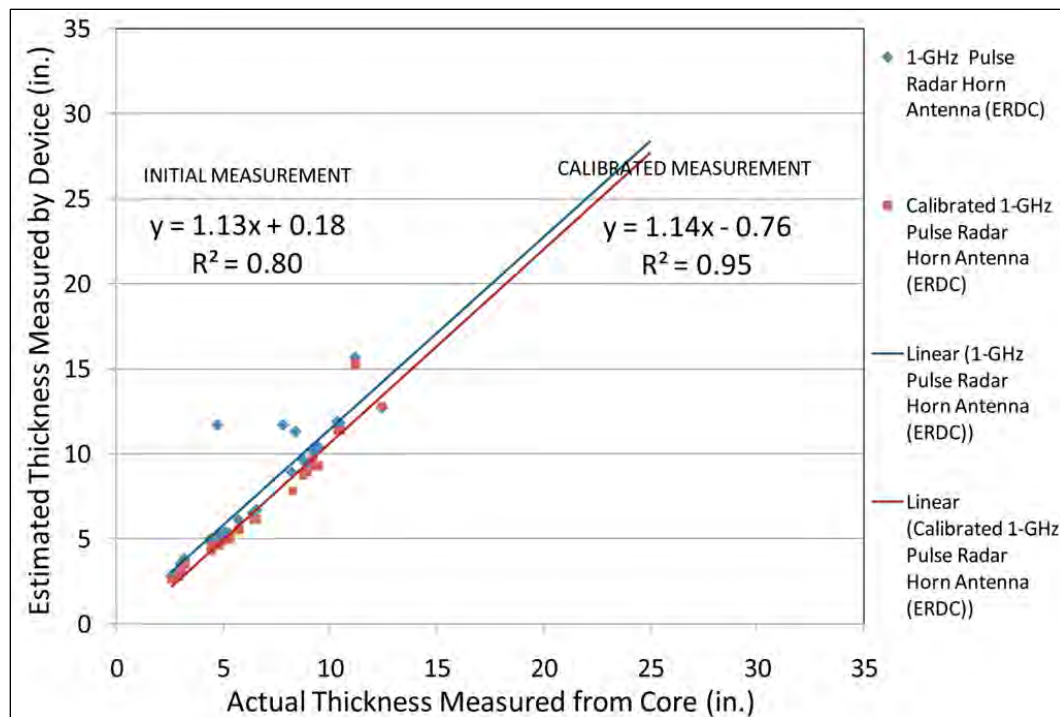
Figure 55. Correlation of actual core thickness and estimated thickness from the 1-GHz Pulse Radar horn antenna (ERDC).

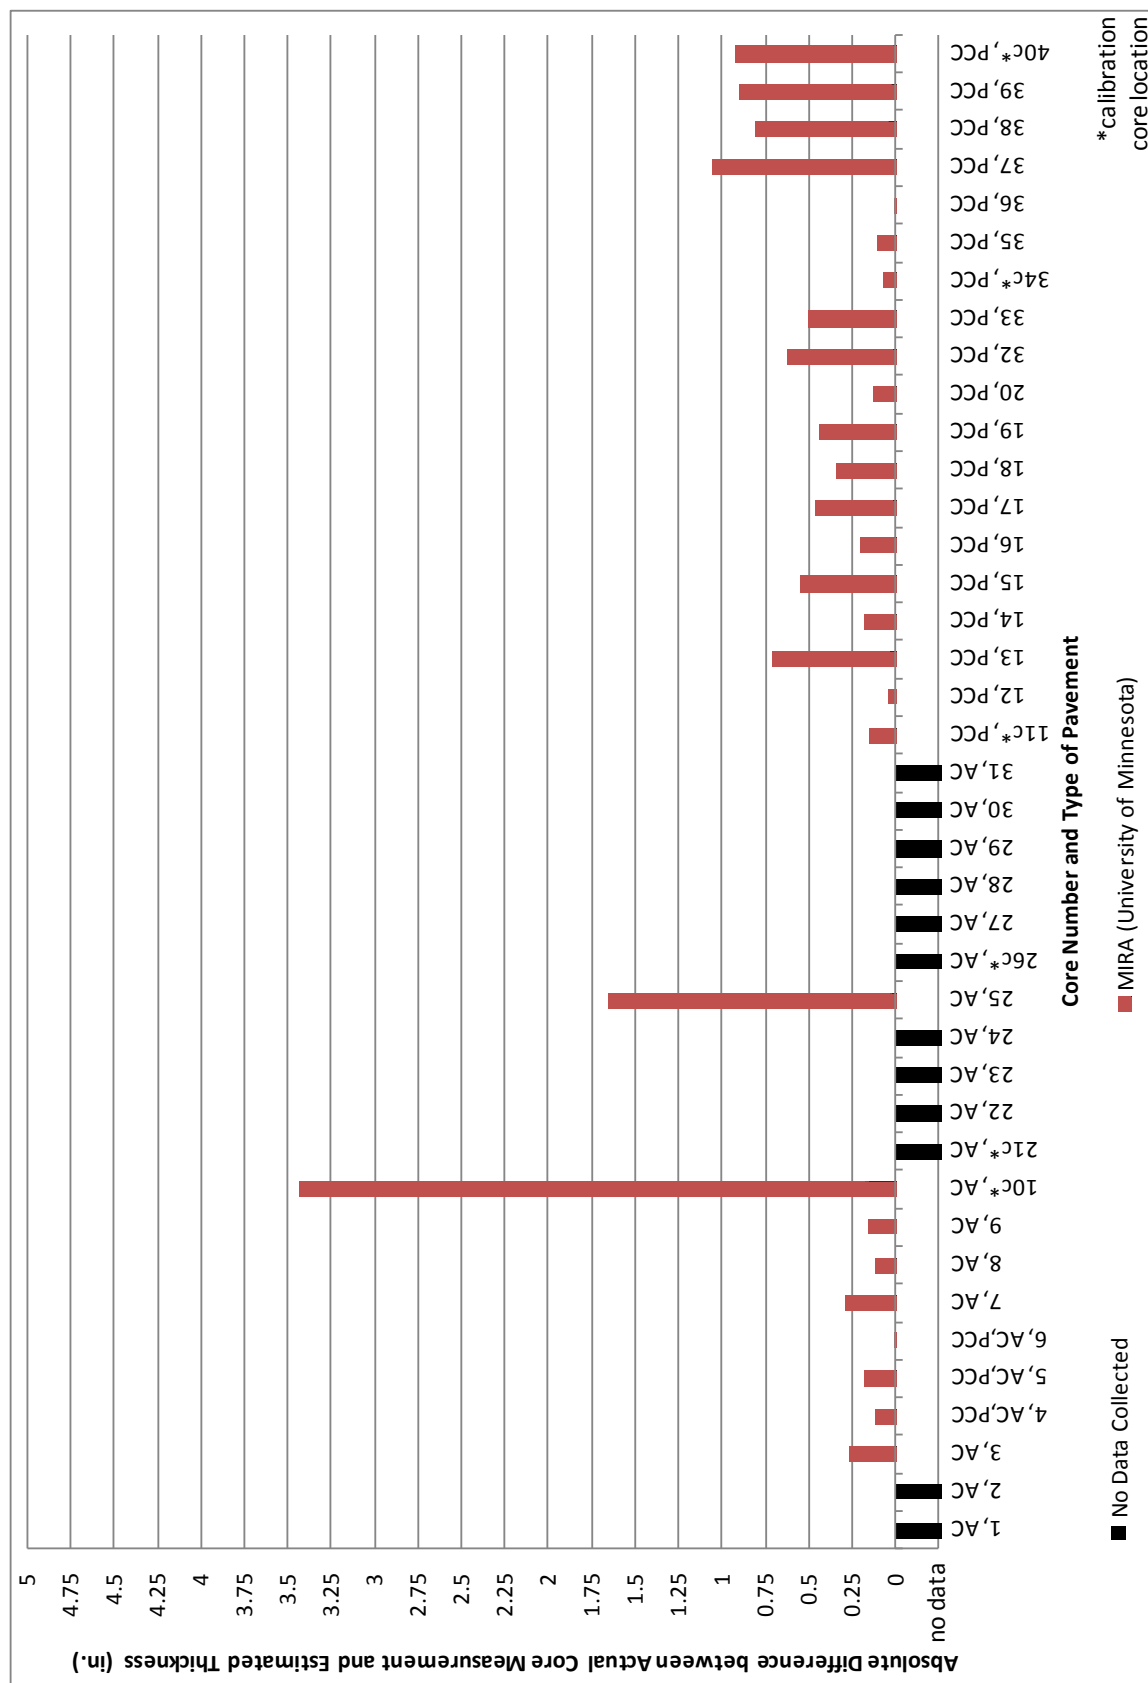
Figure A1. Comparison of the estimated thicknesses using the MIRA (University of Minnesota) to actual core thicknesses.

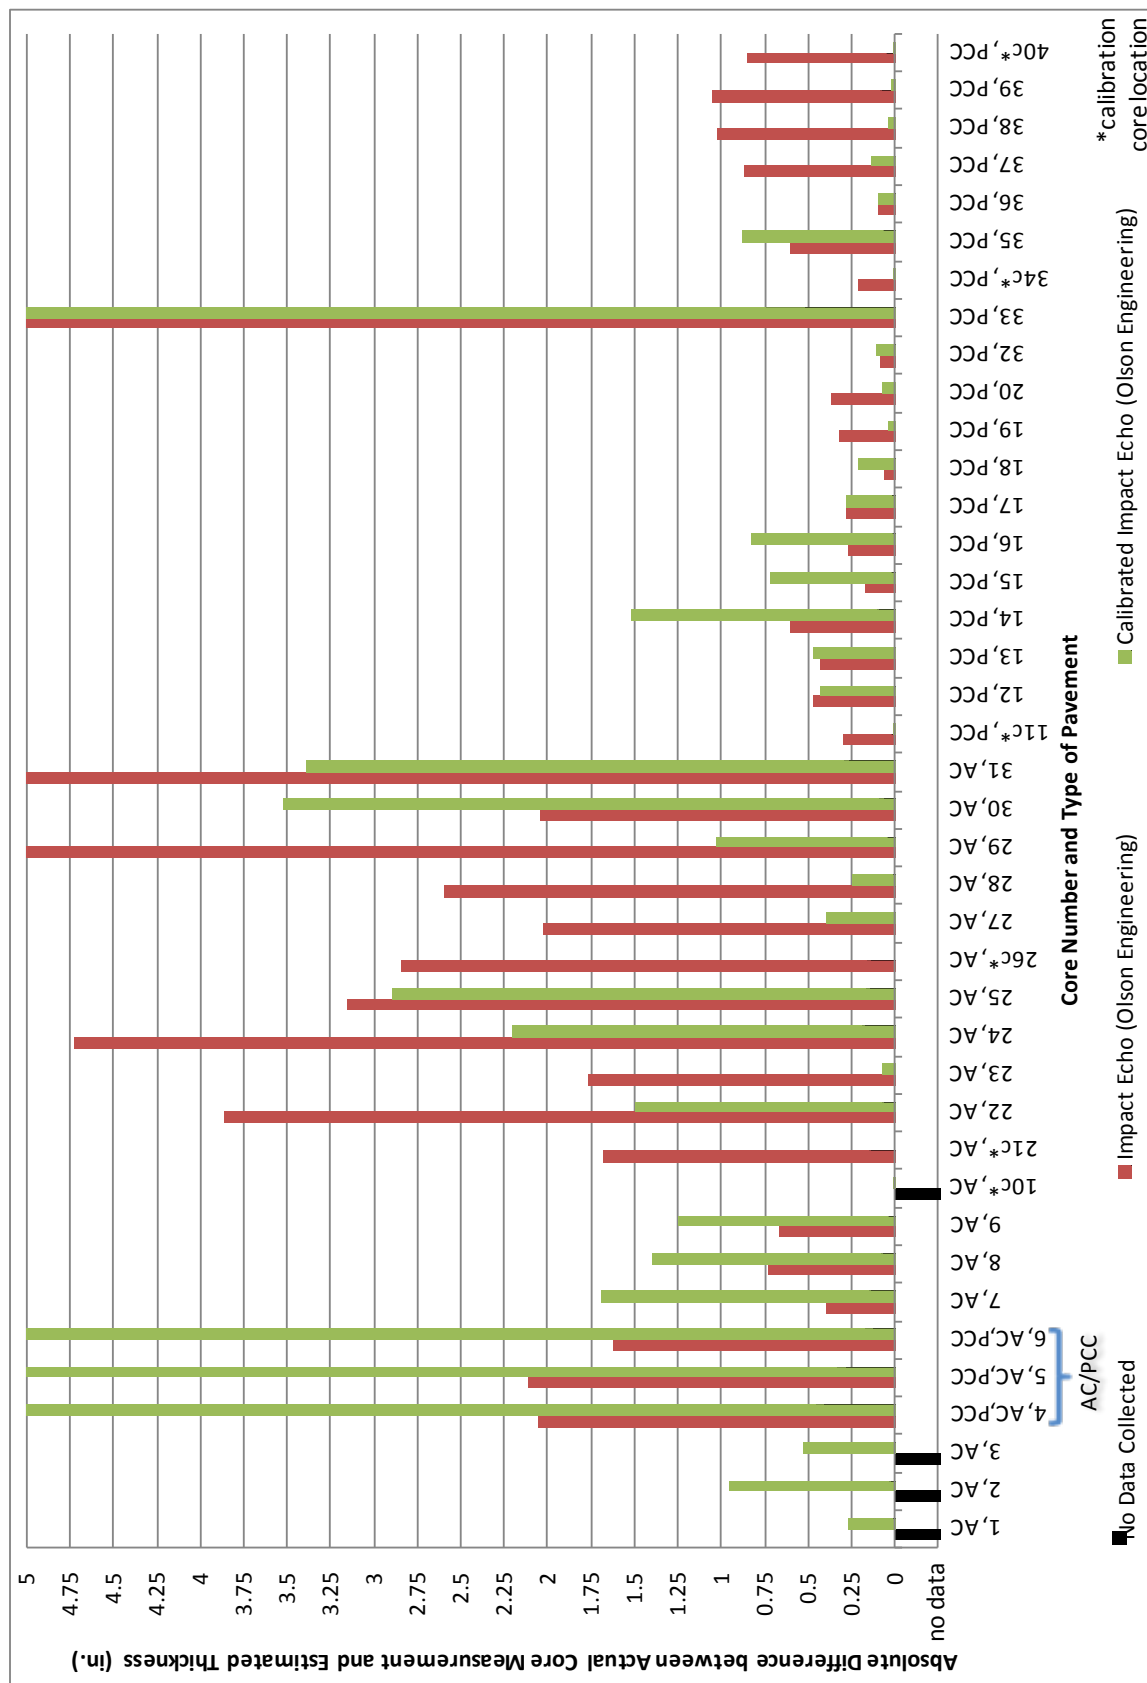
Figure A2. Comparison of the estimated thicknesses using the impact echo device (Olson Engineering) to actual core thicknesses.

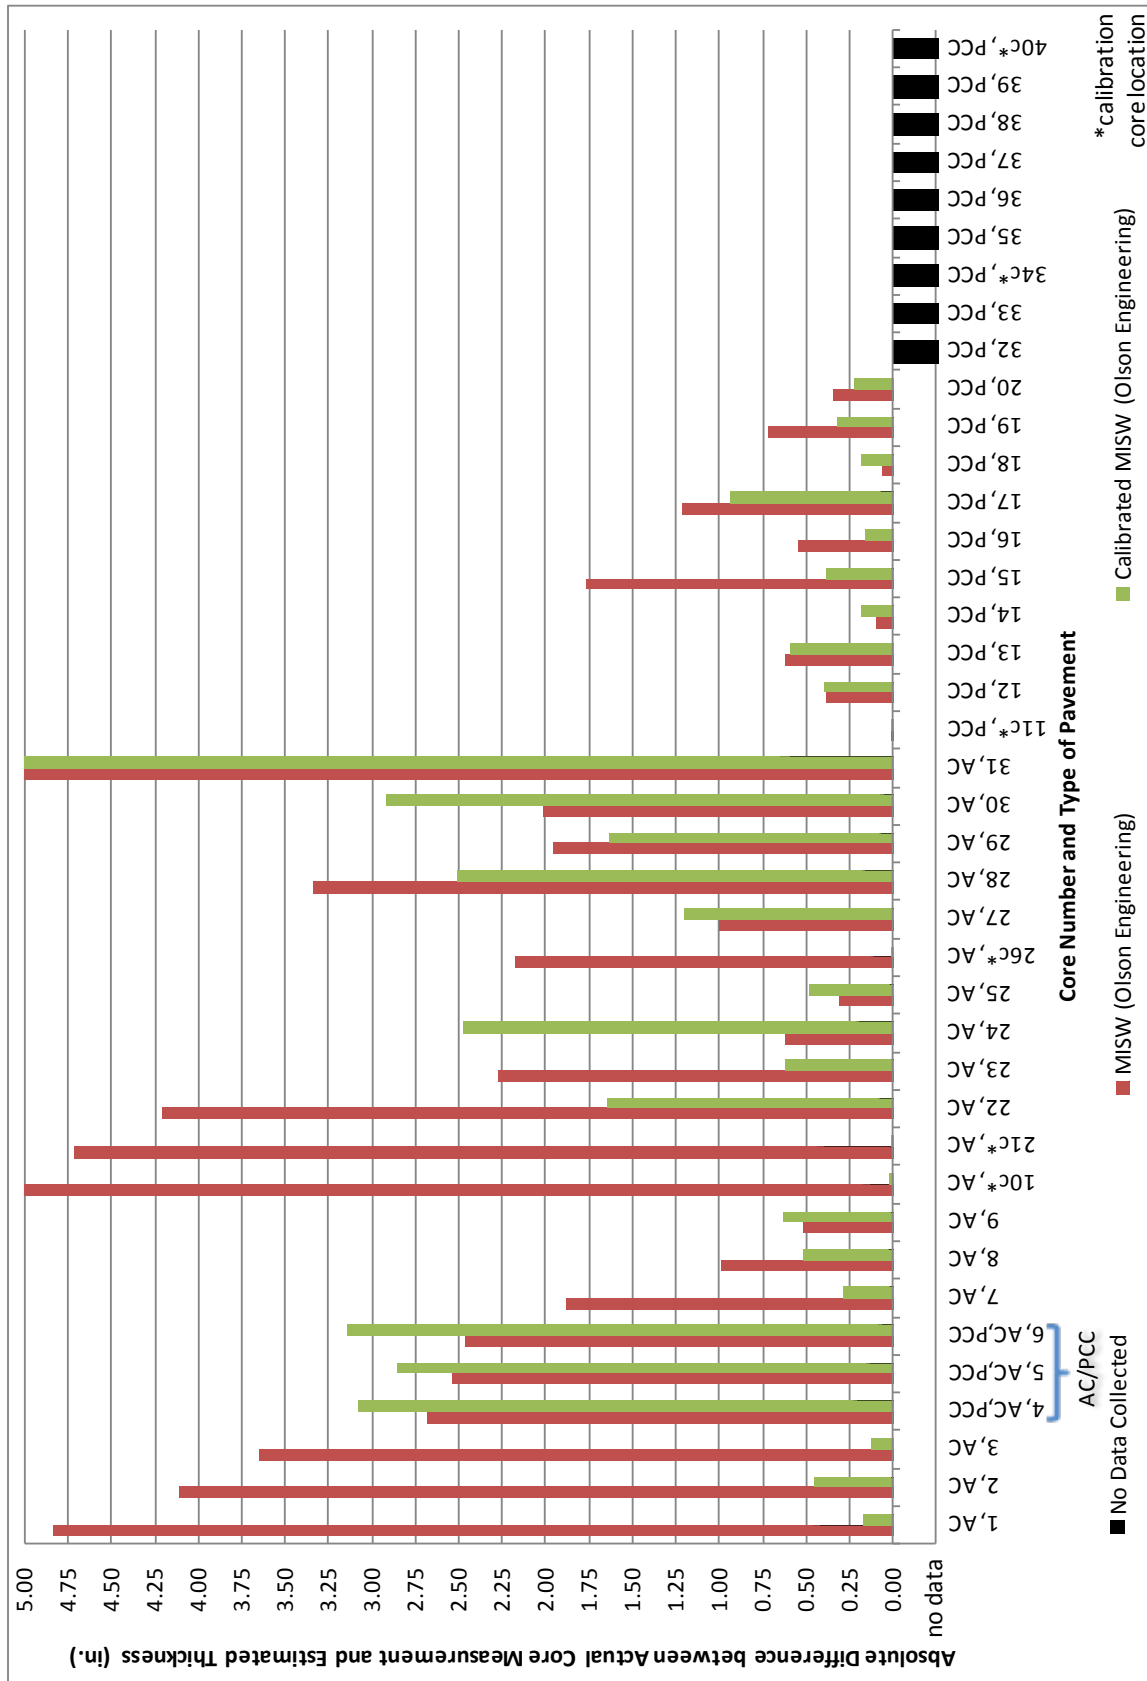
Figure A3. Comparison of the estimated thicknesses using the MISW device (Olson Engineering) to actual core thicknesses.
